Assessment of Bridge Deterioration Using The Bridge Management System Method and Its Maintenance Strategies (A Case Study of Miangas Bridge, Dendengan Luar, Tikala District, Manado City)

Muhammad Rizky Mangkuto¹, Seska Nicolaas^{2*}, Julius E. Tenda³

¹ Civil Engineering Department, Manado State Polytechnic, Manado, Indonesia

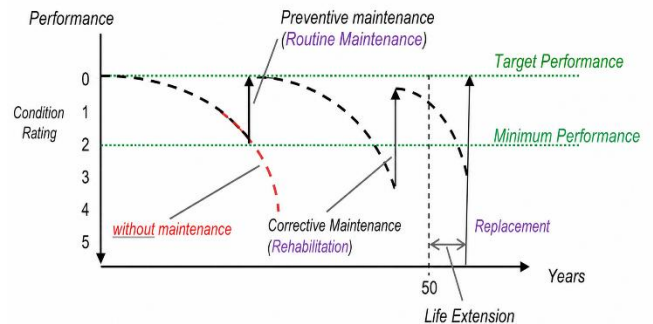
Figure 1 Remaining Service Life of the Bridge

The remaining service life of a bridge is determined based on its existing condition rating. Various factors may influence bridge performance and condition, ranging from environmental exposure to the level of deterioration occurring in individual bridge elements. Therefore, an accurate assessment of bridge condition is essential for estimating the remaining service life and establishing appropriate maintenance and rehabilitation strategies to ensure long-term structural safety and functionality [4].

Based on the relationship illustrated in the graph above, the remaining service life of the bridge can be calculated using the following equation:

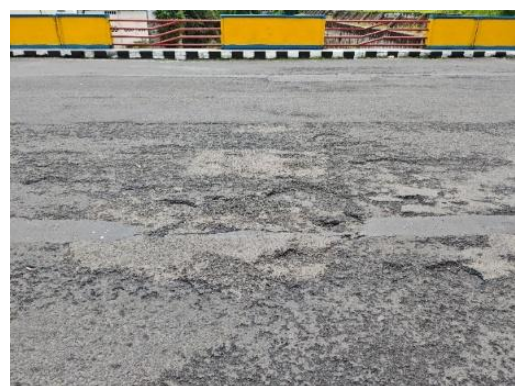
Figure 3. Damage to the Road Pavement

The road pavement exhibited signs of deterioration, including a rough surface texture and localized potholes. However, other sections of the pavement remained in satisfactory condition. Based on the Bridge Management System (BMS) assessment criteria, the flexible pavement was assigned a Condition Rating (CR) of 2, indicating a minor deterioration condition.

Bridge Elements	Condition Score (CR)	Recommended Action
Wearing Surface (Road Pavement)	2 (two)	Mill and resurface the damaged pavement sections, particularly in areas affected by potholes.
Wearing Surface (Asphalt Expansion Joint)	3 (three)	Replace the deteriorated asphalt expansion joint.
Deck Slab	2 (two)	Remove deteriorated concrete, clean corrosion and/or install additional reinforcing

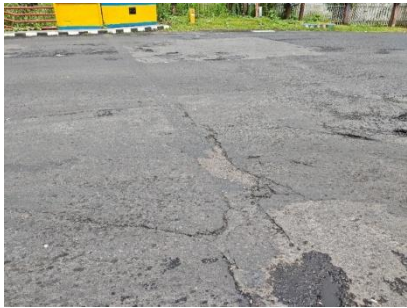
Figure 4 Damage to the Asphalt Expansion Joint

The asphalt expansion joint exhibited signs of deterioration, including a loss of movement capability and debonding from the adjacent pavement surface. These defects may reduce the effectiveness of the joint in accommodating bridge movements caused by traffic loads and temperature fluctuations. Based on the Bridge Management System (BMS) assessment criteria, the asphalt expansion joint was assigned a

Condition Rating (CR) of 3, indicating a major deterioration condition.

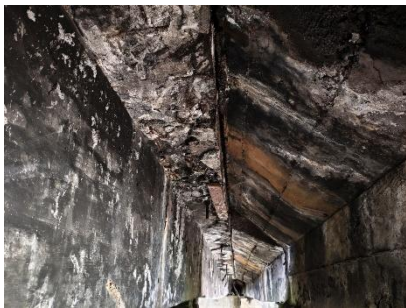
Figure 5. Damage to the Bridge Deck Slab

Based on the field inspection results, the bridge deck slab exhibited signs of deterioration, including concrete spalling that resulted in exposed reinforcing steel. However, the deck slab remains functional and continues to perform its intended structural role. According to the Bridge Management System (BMS) assessment criteria, the bridge deck slab was assigned a Condition Rating (CR) of 2, indicating a moderate deterioration condition.

steel, apply bonding agents, and perform concrete patch repairs.
Bridge Girder (Main Girder)	3 (three)		Remove deteriorated concrete, clean corrosion and/or install additional reinforcing steel, apply bonding agents, and perform concrete patch repairs.
Bridge Girder (Diaphragm)	2 (two)		Remove deteriorated concrete, clean corrosion and/or install additional reinforcing steel, apply bonding agents, and perform concrete patch repairs.
Bridge Pier	2 (two)		Remove deteriorated concrete, clean corrosion and/or install additional reinforcing steel, apply bonding agents, and perform concrete patch repairs.
Overall Condition Rating (CR)	2 (two)		Routine and periodic maintenance

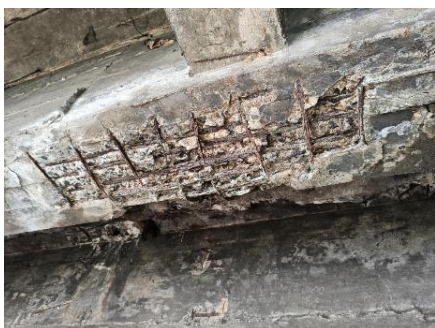
Figure 6. Damage to the Main Longitudinal Girder
a) Diafragma

The main longitudinal girder exhibited signs of deterioration, as evidenced by concrete spalling that resulted in exposed reinforcing steel. The exposure of the reinforcement has led to deterioration of the steel bars, potentially affecting the long-term durability of the structural element. However, the girder remains functional and continues to perform its intended structural role. Based on the Bridge Management System (BMS) assessment criteria, the main longitudinal girder was assigned a Condition Rating (CR) of 3, indicating a major deterioration condition.

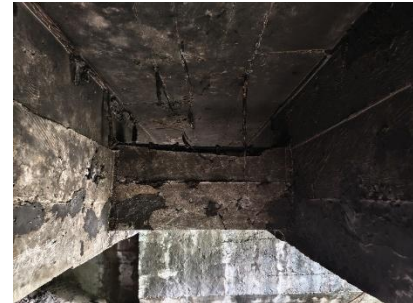
Figure 7. Damage to the Bridge Diafragma

The bridge diaphragm exhibited signs of deterioration, as indicated by concrete spalling that resulted in exposed reinforcing steel. Although the reinforcement became visible due to the loss of concrete cover, the diaphragm remains functional and continues to perform its structural role. Based on the Bridge Management System (BMS) assessment criteria, the diaphragm was assigned a Condition Rating (CR) of 2, indicating a moderate deterioration condition.

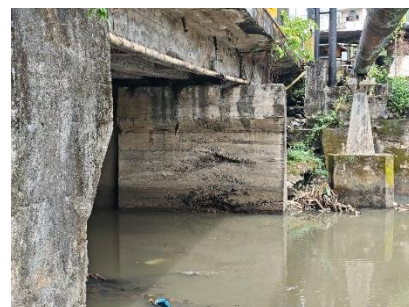
Figure 8. Damage to the Bridge Pier

Based on the field inspection results, the bridge piers exhibited signs of deterioration, as evidenced by concrete spalling that resulted in exposed reinforcing steel. Although the reinforcement became visible due to the loss of concrete cover, the piers remain functional and continue to adequately support the bridge structure. Based on the Bridge Management System (BMS) assessment criteria, the bridge piers were assigned a Condition Rating (CR) of 1, indicating a minor deterioration condition.

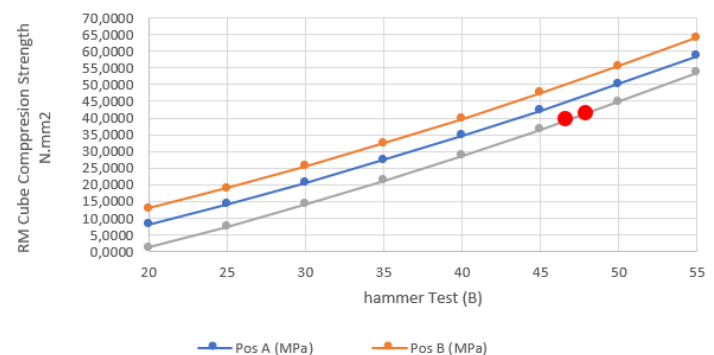
Figure 10 Bridge Slab Concrete Strength Graph

Based on the processed data presented in Table 6 and the graph shown in Figure 10, the estimated concrete compressive strengths of the bridge deck slab were found to be 39.3 MPa and 41.4 MPa, respectively.
